323 Chainplates

"Briar Patch" #210

1979 Pearson 323

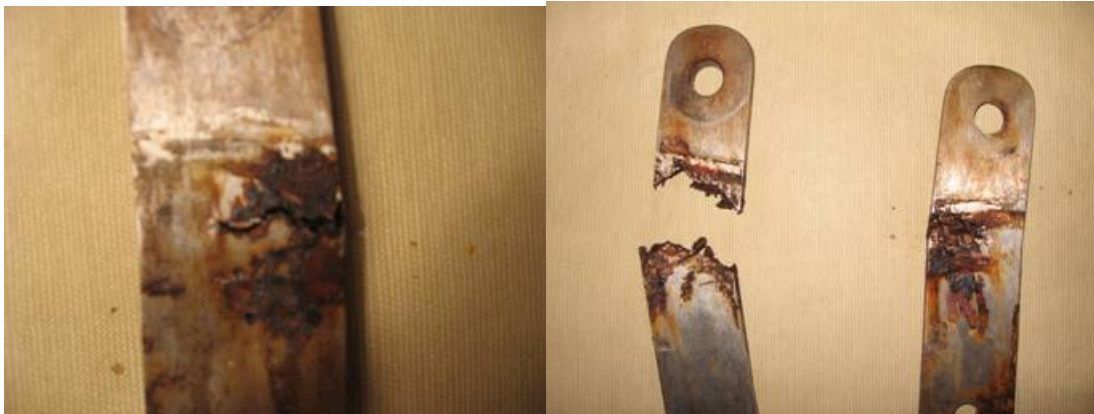
On Friday 13, 2007, I was out sailing on Mobile bay in a nice crisp 15k breeze when all of a sudden my starboard upper shroud gave way. The Chainplate had fatigued right in the joint where the chainplate comes through the deck. I had just done a physical survey of the standing rigging one month before and had looked at the chainplates, bolts etc., as well as rigging from masthead on down. Everything looked fine. The chainplates seemed strong, with no corrosion, and the bolts and turnbuckles looked clean and fit.

What I could not see was inside the joint where the chainplate bar comes through the hull. This afternoon I pulled all three chainplates off on the starboard side and found that also the aft lower chainplate was half way broken at the exact same place. The forward lower seemed to be sound, however it was bent slightly at the head where it comes through the hull. Tomorrow I will pull all the port side chainplates and examine them.

Even though the mast has been stepped several times in her life, the chainplates have never been removed and examined. I would suggest to all 323 owners that if they have not, that they look closely at the structural integrity of the chainplates specifically looking for stress/breakage at the point where the chainplate comes through the deck. At a minimum I would recommend removing the deck plate around the chainplates, but would suggest removing the entire chainplate and checking it more closely.
