The restoration of Áine

Rejuvenating a Pearson 323

Primary Winches – Oh Boy!

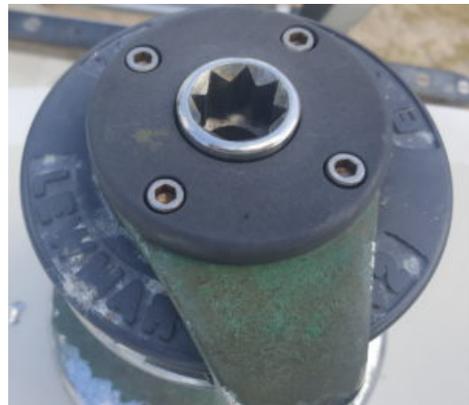
The external condition of my winches was really poor. Most of the chrome plating on the drum and line stripper arm was either completely gone or was peeling off with every gust of wind. The winch design is mechanically time tested, but for this design they elected to mix bronze, aluminum, and stainless steel. The drum is cast bronze which is chrome plated and includes a line-wrap gripping pattern in the center of the drum (which was completely missing from my drums). At the top of the drum is the lower line locking teeth of the self-tail. The upper line locking teeth of the self-tail are on the crown plate and is cast aluminum which is black anodized. The line stripping arm (which causes the line to exit the line locking teeth) is also black anodized cast aluminum and is located between the upper and lower teeth. Three 1/4" – 20 1" long stainless steel socket head cap screws hold the aluminum crown plate to the bronze drum. Next is a plastic flange bushing (separates the crown plate from the stripper arm). Then the stripper arm (which guides the line from the drum into the self-tail teeth), it's cast bronze and chrome plated. To finishing everything off, on

top is a molded plastic cap which holds the bronze split locks (collets) in place. Four 1/4" – 20 3/8" stainless steel socket head cap screws secure the top cap to the cast stripper arm.

The biggest problem with disassembly is galvanic corrosion where the Aluminum comes in contact with the stainless steel screws in the crown plate. Even though the crown plate is drilled with clearance holes, that didn't seem to matter much. The screws were locked in place and 2 of the 3 sockets head cap screws sheared off at the head. It took some persuasion (hammer and steel rod from below) to loosen the crown plate from the screw shafts. Once the crown plate was out of the way, I could removed the remaining screw shafts with my fingers.

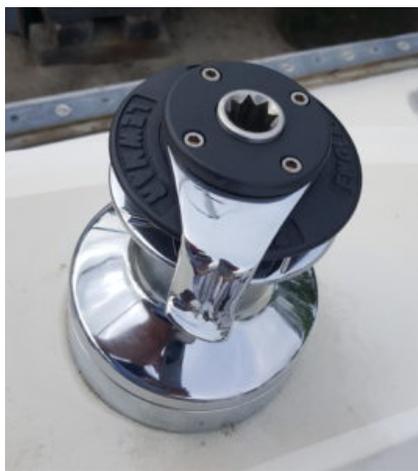
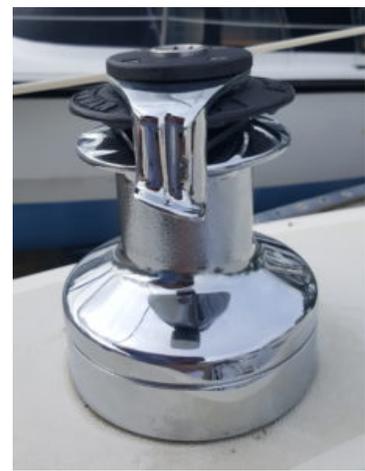
All of the black anodized aluminum pieces had corrosion and pitting on all sides. I found a local hard

chrome platter and dropped off the drums. He glass beaded the drums (a form of sand blasting which is less aggressive) and to my surprise returned the gripping pattern to the middle of the drum. I scraped off the gross corrosion from the Aluminum parts with a small straight blade screw driver and then scotch-brighted all surfaces.

Next I cleaned the aluminum parts with a strong acidic cleaner. Lastly I painted all the aluminum parts which do not come in contact with line using a flat-black outdoor spray paint. I also painted the plastic top cap to match the aluminum casting. I know that the paint will deteriorate with time, but the gorgeous drums just didn't look right with the 'natural' faded-and-deteriorated looking aluminum.

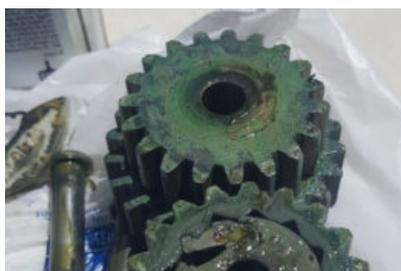
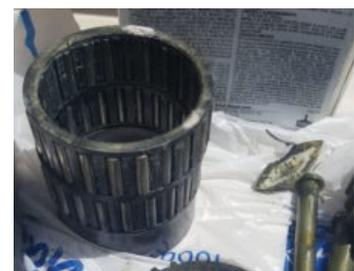
With the drum removed, I took my first look at all the moving parts inside. What a sight, it all looked like crap and the grease felt sticky like molasses or thick honey and I could not hand turn

anything. The pawls, pawl springs, the two gear spindles, and main spindle (winch handle attachment point) are all stainless steel, everything else is

bronze or plastic. I used mineral spirits in a bowl and a tooth brush to clean everything. But that did not remove all the years of hardened sand and grease. I used a small straight blade screw driver to

scrape out all the hardened remains from the valleys and tips of the gear teeth followed by another mineral spirits scrub. Finally I scotch-brighted everything to remove the remaining hardened bits. All of the gear assemblies were then dry fitted and tested for proper operation. I replaced all the pawl springs.

Finally satisfied that everything was as good as it was going to get, I greased the gears, oiled the pawls and reassembled the winch. It looks like it just came out of the box and worked perfectly, feels smooth-as-silk.
