## Mast Step

*Contributed by Cliff and Bezy McKay on Ceilidh (Kaylee) Hull 261*

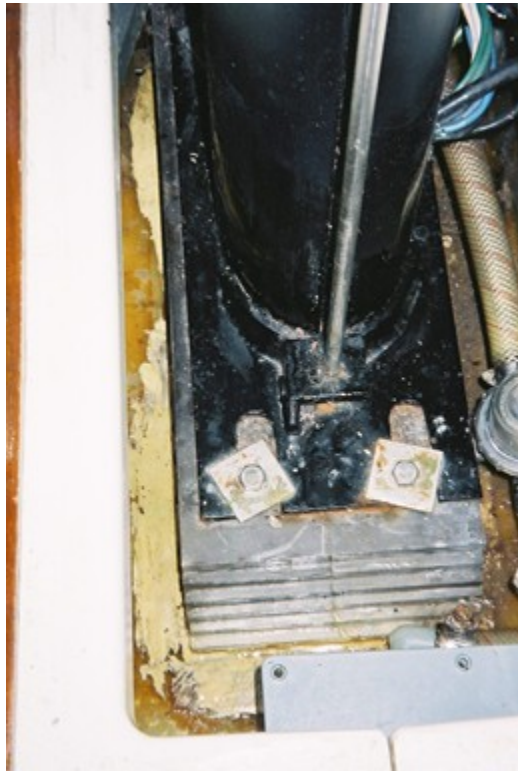
When our P323 was 8 years old the bottom of the mast was significantly corroded. Evidently the upper bilge slants forward and any water in the upper bilge sits at the mast step. We had to cut off the mast 3" and build a 3" platform for the mast step.

9 years later, we discovered the step was sinking into the platform made of plywood, covered over with fiberglass. The yard manager in Southwest Harbor, Maine said we needed polycarbonate (lexan) to support the compression load of the mast pushing downward. I bought 1/2" thick lexan from the scrap bin of a Plastics place for \$1 per lb, \$22 for the project. I cut six sheets, epoxied them together; recessed lag bolts into the top sheet then bolted the stack to the keel. Next, I bolted the step through 5 of the layers to hold it in place on top of the lexan. It provides a solid, water resistant support to hold the load of the mast, firmly fastened in place.

Before you start this project, **it is vital to mark the location of the step** since there is not more than an inch adjustment, fore and aft, in tuning the mast. Mark and be sure to relocate the step in the exact position in the boat.
