## REBEDDING FIXED PORTLIGHTS

Rick Lucas: *Ping*

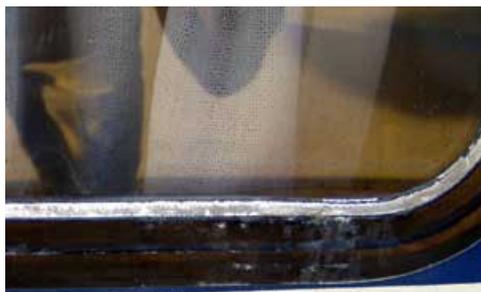
Ping is 25 years old and she has leaks. Not below the waterline but above decks. The worst was in one of the large fixed portlights. When I'd hose down the boat after a good sail, a damp spot the size of a 45 RPM record would show up on the dinette seat cushion. Immediate attention was required. I tried to take the portlight out before, but a previous owner had poured enough silicone into the gap than you'd find on Rodeo Drive for a sale at Louis Vuitton. Although it didn't keep the water out, it held the portlight firmly in the boat.

OK... this required some planning. I reviewed the emails I'd saved on the topic from the SailNet message boards. It was a good place to start but there were as many opinions as there were posters. Armed with all that good information I went to the boat with my tools. The most important being my Dremel. Others had problems getting their portlights out and the brute force they used could break the glass. The Dremel was my finesse. I used a small, triangular bit to rout the silicone out from between the portlight and the deckhouse and it did a great job without gouging either.

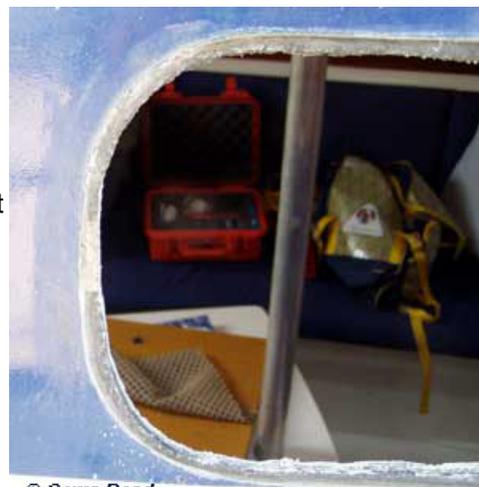
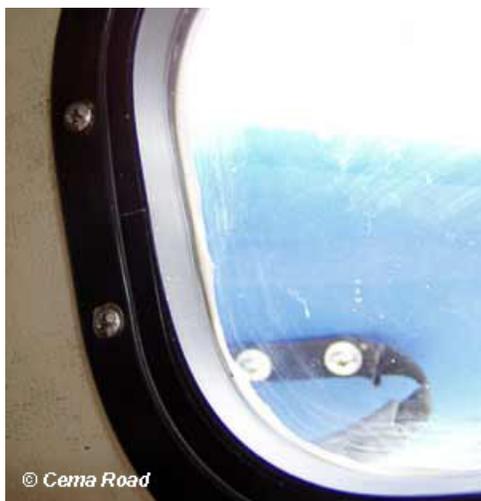
Once I had enough silicone out and could move the portlight slightly outward, I went on deck with a razor blade and cut away at the foam tape that was used by the factory to bed the light. Soon the portlight was free and in my hands. I have to say that foam tape is not what I'd choose to keep the water out of the cabin with an opening that big, but I don't build boats for a living. The foam tape didn't look as though it had deteriorated too badly, but it had lost a lot of its elasticity. I didn't really think it was the cause of the leak, but rather that the seal between the glass and aluminum frame had expired somehow, so I had to take that apart.

The two halves of the aluminum frame are held together with a total of four screws and two metal tabs that I then undid. With a little muscle, the metal pulled away from the glass revealing a black rubber gasket circling the perimeter of the glass. There was also some factory applied silicone that I thought was a gasket sealing the inside of the frame to the glass to keep the water out. It looked like a gasket because the elements had oxidized the part of it that was exposed. Time had not been kind to this seal and I believed that I found the source of my leak.

After scraping and cleaning all of the old sealant from the glass and frame I reassembled it, this time using white 3M 4200. Next I cleaned up the deckhouse opening and the outside of the frame and bedded it with black BoatLife sealer. Because the opening was larger than the portlight, I shimmed the frame with some high-density closed-cell foam to get it into proper alignment then screwed on the interior bezel. Aside from cleaning up the overflow that oozed out between the frame and the deckhouse, that was it. All that was left was to let the sealers dry and trim the sealer between the frame and the glass.
