STABILIZING THE SETTEE TABLE

Rick Lucas: *Ping*

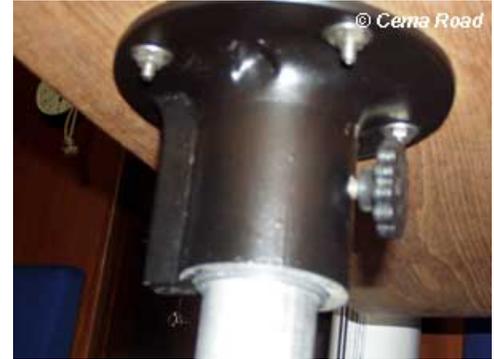
For reasons unknown to me, Ping's PO replaced the support pole and both its mounting brackets. The new bottom mount had nothing to keep the pole from turning, and the top mount just couldn't do the job alone. The table secures to the pole by a round bracket that exerts pressure on the pole with a knurled screw knob. When a 200 lb. man leans on the corner of the table without the pole being fully secured, something had to give. In this case, it was the pole turning in its mounts.

I was convinced that the table/pole link was sufficient to hold the table in place so I turned my efforts toward the two mounts at the top and bottom. The teak that was used at the top was very well honed and looked very nice, but the two screws that were originally used to affix the pole to the base were splitting the wood and pulling it apart. The two pieces of wood that made up the assembly were also not securely fixed to one another, allowing the one with the pole attached to it to shift around inside the larger piece. Those two issues needed to be resolve.

The solution was not the most elegant I've ever devised, but it was effective. I first unscrewed the wooden base from the cabin roof and removed it from the pole. I applied some polyester glue to bond the two pieces of wood together and set the assembly aside to dry. Polyester glue works wonderfully well on wood and other substances, but it has a tendency to expand and bubble out from the gaps as it dries. The bubbles can be easily removed within 24 hours of application, but after it has fully cured you may as well try to separate the minstrel from Jimmy Buffett! The tan residue you see in the picture at left is the part of that overflow that I couldn't remove a week after I applied the glue. Oh well. If I get motivated, I can probably clean it up with a Dremel cut wheel.

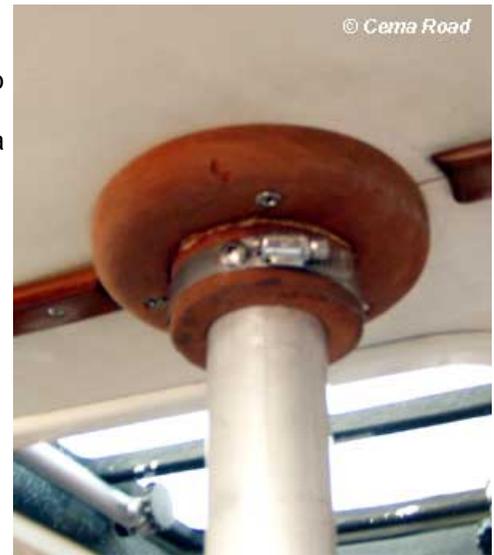
The other solution is where the cosmetic aspects of the solution get really dodgy. The screws that went through the wood and into the pole would cause the wood to split when lateral pressure was applied. I didn't think that glue would be enough to put this Humpty Dumpty back together for the long term because the wood grain ran vertically, from the top of the piece to the bottom. Fixing one split would only invite another.

A hose clamp was the best thing I could come up with to keep the wood from splitting and providing a solid surface that would keep the screws and the pole in place. I first put glue on the split wood on the inside, where the pole would go. I then tightened the hose clamp around the wood and slid the complete wooden base over the pole. I then drilled two holes in the hose clamp in line with the existing ones in the wood base. Next, back went the screws into the holes to hold it to the pole, and I screwed the whole mess back into the cabin roof. Once all the glue had cured, I gave the table the pressure test. Success! The two screws held the pole to the

teak bracket and the table didn't move... much.

(UPDATE: I removed the cap and epoxied the two pieces of wood together. There was enough room above the level of the tube to add some glass fabric for added strength. I also replaced the two screws and clamp with long, thin bolts that go all the way through. It turns out that with the brackets on the foot of the tube [described below], the clamp was no longer needed.)

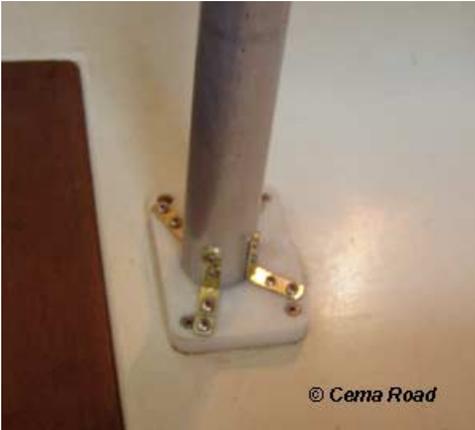
I did notice that the bottom of the pole would still move around a little when I moved the table. Some kind of angle brackets seemed to be the answer. I couldn't find anything suitable at the local chandlery or at SailNet so I searched until I found some in solid brass at the local Ace hardware store. I know that brass isn't the strongest metal, but I didn't want it to take the whole load. I just needed them to provide additional stability to the bottom of the pole. That it did. While not perfectly solid, the table's motion is now less than one inch.

The solution, at present, is a tradeoff. The table's stable, but the aesthetics of the installation aren't quite as nice as they used to be. Since I don't know what was there originally, I don't have the benefit of the factory installation as a model. So, for now, I'll leave it as is.
