Manual Bilge Pump Rebuild

September 2012

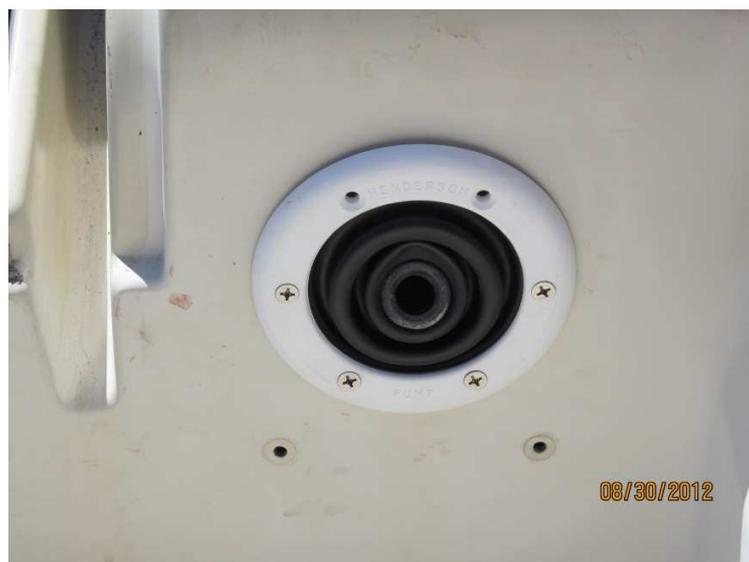
Everything goes back in reverse order. I installed the flexible rubber seal over the rocker arm first, using a lubricant (spit) to make the process easier. I then pushed the flexible seal thru the large opening in the cockpit wall from inside the cockpit locker. The order of installing the (8) fasteners can make your job much easier. I would recommend installing the (4) fasteners shown in the picture below first.

During the process, I noticed that the flexible rubber seal in the cockpit that seals between the rocker arm and the vertical cockpit wall was also torn. Removing the (6) countersunk screws that hold the white plastic face plate and flexible seal in place was a snap. The uppermost (2) fasteners in this pattern help hold the MBP rear cover to the vertical cockpit wall. Removing (2) more countersunk screws below the deck seal allows the rear cover to be completely removed from the boat. The photo below shows the (4) fasteners that actually hold the MBP to the cockpit wall **not in place yet**.
