# The restoration of Áine

Rejuvenating a Pearson 323

## New Cabin Top (Doghouse) Handrails

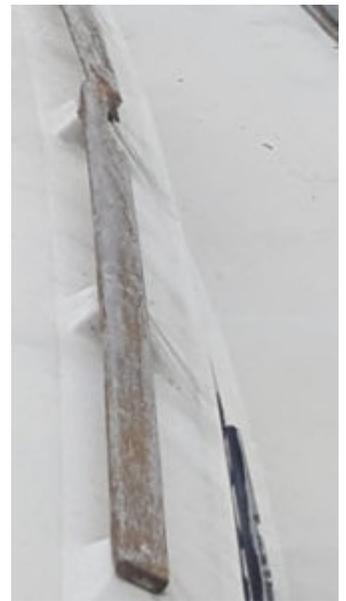
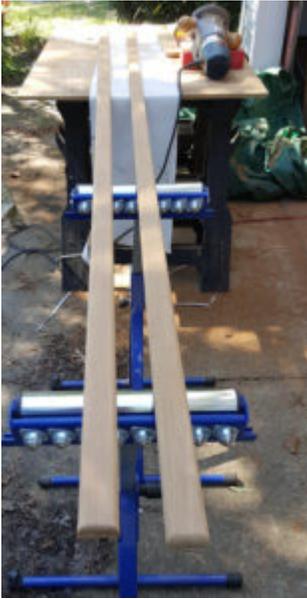
I located a piece to teak lumber which was 17' x 5" x 1" rough cut, it would yield 2 hand rails 3/4" thick and I've have some extra teak for other projects. I spent the next day in the shop just making enough room to cut, plane, and sand a piece of wood this long, it had to be able to go out the front door for both cutting and planing. 2 days later it was finished and I had 2 beautiful pieces of wood. You know you have good quality teak by the feel, smell, and how it works with tools. I put a 3/8" radius all around the top side and a 1/4" radius on the bottom side. It felt good in the hand and left a larger mounting and sealing surface for attachment to the pedestals.

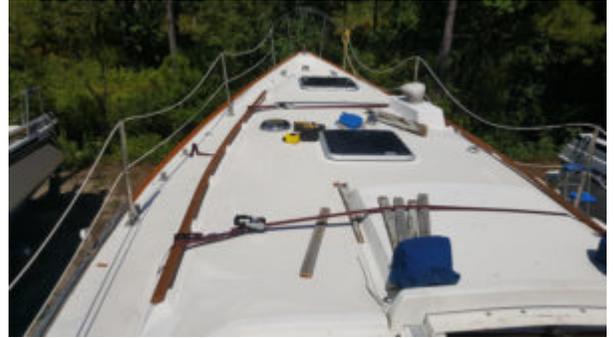
Installation was easy, I mean really easy... I marked the center of the first handrail and drilled and counter sunk a hole for a 1 1/2" long #10 SS flat head sheet metal screw. The counter sink hole was 3/8" in diameter to accommodate the screw head and 3/8" deep so a teak bung could be installed. I positioned the handrail in the middle of the

pedestal and drilled a smaller hole in the fiberglass and attached the screw. The only reason this worked is that there is an odd number of pedestals so the center is easy to find. I attached ratchet straps to the starboard rail aft and starboard stanchion forward. This allowed me to easily bend the handrail for the next pedestals fore and aft. I went fore and aft one by one, slowly bending and attaching the handrail. Once the port side was complete I moved everything to the starboard side.

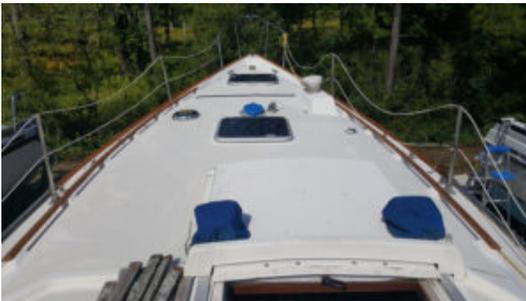
On the right is a picture of the before and after handrails.

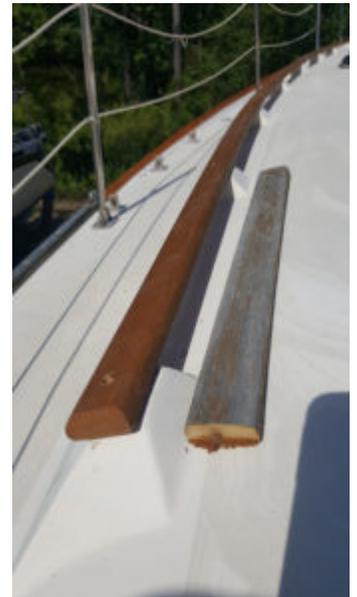
The completed job on the left came out nicely.
