HEAD HATCH

Rick Lucas: *Ping*

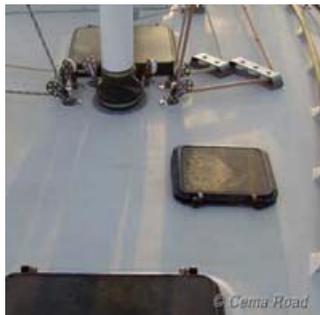
When I bought Ping, a PO had already installed a 10" Bomar hatch in the head that was of the same type that Pearson installed at the yard. It doesn't leak so I assume that the bedding was done properly. The only problem was that the installation below decks was, shall we say, inelegant. There was a rudely cut hole in the liner above the head that exposed the gap between the liner and the fiberglass deck. Yeah it worked, but it wasn't pretty. Since Ping is a labor of love, I wanted to repair this open sore and extend the attractive woodwork Pearson designed into the boat to this modification.

I never looked into what Bomar might have in the way of interior collars that might work for this because I like wood, especially below decks where it doesn't need annual maintenance. I thought that I could use wood strips to build a frame that would fit into the opening in the liner. I had no delusions that my woodworking skills could yield a snug fit between the frame and the fiberglass roof so I didn't try to do that. I simply made a square frame that would fit the hole and rely on something else to fill the last few fractions of an inch to close the gap.

Working with a hatch inner dimension of 9 7/8", I used a miter box to cut the four strips that make up the bottom frame pieces. Once I got those squared up, I cut four more pieces that would sit on top of the first four and extend vertically into the opening in the shell. Although I'm not sure if it's up to Norm Abrams' standards, my multiple measurement yielded eight pieces of bevel-cornered teak that made a square frame with an "L-shaped" flange that extended up through the headliner and out parallel to it.

With the help of four cheap corner clamps I found at my local Ace Hardware, I first glued the bottom four boards together with Pro-Bond glue. Then glued the top four. Once they'd all set up, I laid the two assemblies together and was very surprised when I found the sizes really close and all the corners square. Using C-clamps and glue, I bonded the two wooden squares together. Once firmly bonded, I used my orbital sander to smooth out the joints and prepare the wood for finishing.

Applying the same wood finishing techniques that I used on the rest of the cabin (see [Cabin Refinishing](#)), I applied four coats of Minwax Spar urethane to the exposed surface, and also lapped a couple of coats on the back side of the glued joints to provide protection against moisture. (Pro-Bond is, I think, water-based glue that would probably not take kindly to a lot of water.) It looked good on my workbench, but would it fit?

I screwed and glued two small pieces of scrap wood above the liner on the starboard and port side of the opening. To these I screwed the frame from inside the opening. It fit perfectly... almost. What remained was a gap between the top of the frame and deck above. A trip back to Ace Hardware found some thick and wide closed cell adhesive weather stripping that I stuck to the bottom of the decking. This closed the gap above the frame and completed the job.

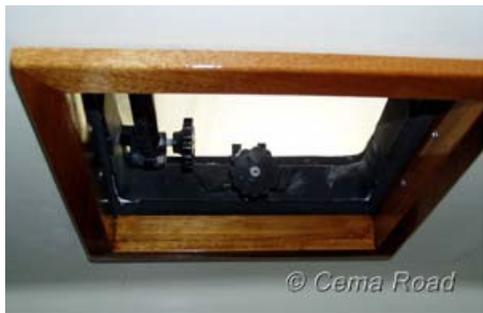
The rough hole in the liner needed to be made larger. Using the frame as a template, I drew a pencil line around the wood strips. A Dremel cutting wheel cut the hole to size and a Dremel grinding wheel opened the spots that were still a little too close. **Note:** I put a small shop vac on deck with the nozzle by the wheel to keep the nasty dust out of the boat. You don't want to breathe this stuff.
